Issue SAB 35
November 2014

Bunsen burner mats

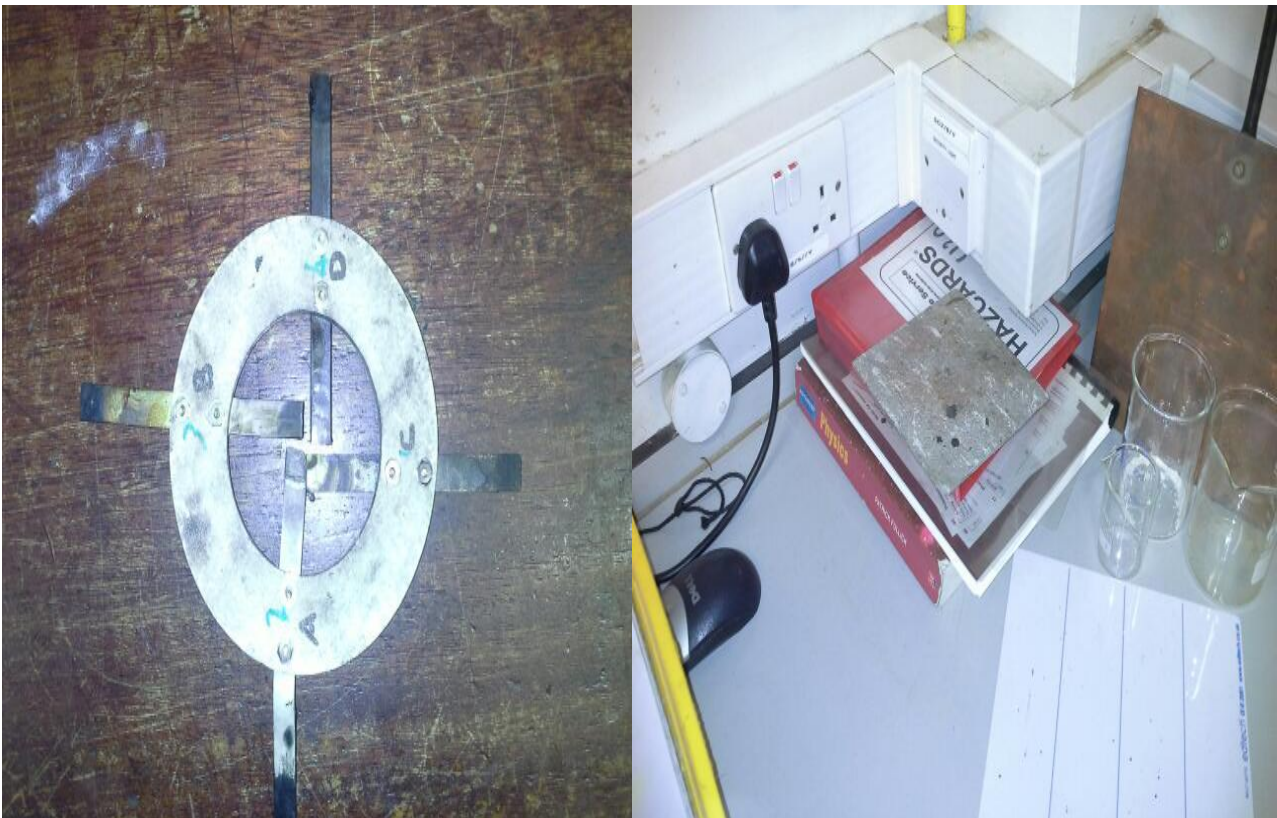
During the current asbestos survey programme, it has been identified that some old Bunsen burner mats (age Pre 2000) are still in use. A few have been tested and this has identified that they contain asbestos. Please see below two photographs for identification purposes.

- The mats are used for prevention of heat transfer purposes usually associated with Science.
- They could be used by several other curriculum departments such as Art and D&T.
- They have different designs, dimensions and shapes (please see photographs above).
- Unless it can be proven that they are manufactured after 2000 then it has to be presumed they contain asbestos.
- All areas which contain stored items should be checked as they may have been stored away for many years and forgotten.
- The risk from the mats is very low if they are undamaged.
- Any damaged mats should not be touched but arrangements must be made for their proper disposal.

- All departments should check their work spaces including all storage areas.
- Any general storage areas should be checked as they could be stored away from the point of use.

- Any damaged or broken mats should be left and reported immediately to the Schools Health and Safety Team. The area should be locked and no access should be granted to anyone unless they are a competent asbestos contractor.

- If any are found and are undamaged then use two robust bin liners to double bag them and seal the bags. Ideally use 1000 gauge polythene to double wrap.

- The bagged mats should be locked away so no one has access to them.
- A warning label should be attached to the bag identifying possible asbestos content.

- Contact the Schools Health and Safety Team on 01865 797222 to arrange removal as hazardous waste.
- If you need any advice or assistance then please contact the Schools Health and Safety team.
